Army Lodging Wellness Recommendation

Fort Gordon - Final Submittal

August 18, 2003

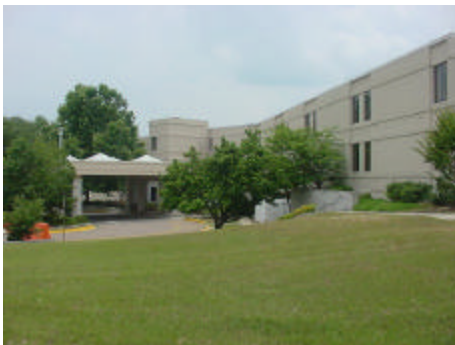
Building 250, Griffith Hall, constructed in 1967, is a 4-story building housing 132 standard rooms 14 family suites, and 2 two-bedroom suites, for a total of 148 guest rooms. This building serves as the main Lodging facility with all of the public and back-of-the-house functions for the installation and was recently renovated to include an elevator addition and porte cochere at the main entrance. Access to the rooms is through a 5'-0" wide interior hallway.

The building is in good condition and meets a majority of the Army functional standards. The public and back-of-the-house spaces however, do not include all spaces required for a main lodging facility including in-house laundry, storage, maintenance, and breakfast area. The Wellness Recommendation will be to renovate these spaces to meet Army Lodging standards for a secondary facility, and add a new main Lodging facility at this installation. To renovate Building 250 to the new standards and configuration will not exceed the 50% replacement cost.

Our recommendation is to retain Building 250 in the Lodging inventory. This facility will remain in the Fort Gordon Wellness Solution and Lodging Master Plan.

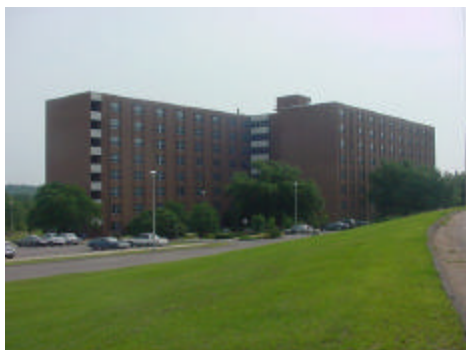
Building 36700, Ring Hall, constructed in 1972, is an 8-story building housing 290 extended stay rooms and 8 family suites with kitchen for a total of 298 rooms. There are two elevators, and access to the rooms is through a 5'-0" wide interior hallway. The rooms meet most of the Army Lodging standards, but many of the building's systems are approaching the end of their useful lives. Although the cost to make condition assessment improvements is just over the 50% replacement cost, it is our

recommendation to remove this facility from the lodging inventory due to the age of the building and building systems.

Our recommendation is to retain Building 36700 in the Lodging inventory. This facility will remain in the Fort Gordon Wellness Solution and Lodging Master Plan.

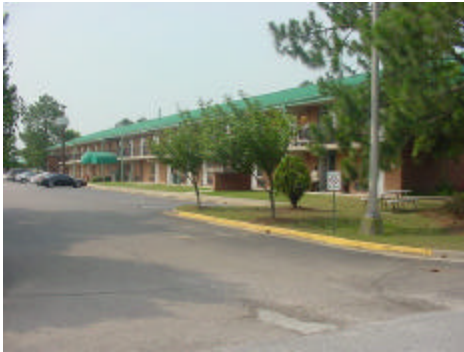
Building 37300, Stinson Guest House, constructed in 1971, is a 2-story building housing 73 standard rooms. There are no elevators, and access to the rooms is through an exterior balcony. This building originally belonged to MWR, and the original guest registration area has been reconfigured to provide for a guest breakfast area for this building and the Stinson Annex, which is located directly adjacent to this facility. The building is in good condition and meets a majority of the Army functional standards. To renovate Building 37300 to the new standards and configuration will not exceed the 50% replacement cost.

Our recommendation is to retain Building 37300 in the Lodging inventory. This facility will remain in the Fort Gordon Wellness Solution and Lodging Master Plan.

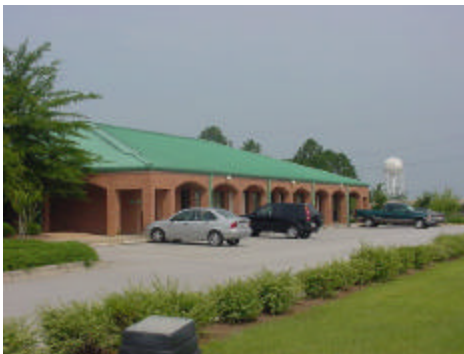
Building 37302, Stinson Guest House Annex, constructed in 1989, is a single story building housing 32 standard rooms. The rooms are accessed from the exterior. The building is in good condition and meets a majority of the Army functional standards. To meet the demand requirements, these rooms will need to be converted to extended stay rooms. To renovate Building 37302 to the new standards and configuration will not exceed the 50% replacement cost.

Our recommendation is to retain Building 37302 in the Lodging inventory. This facility will remain in the Fort Gordon Wellness Solution and Lodging Master Plan.

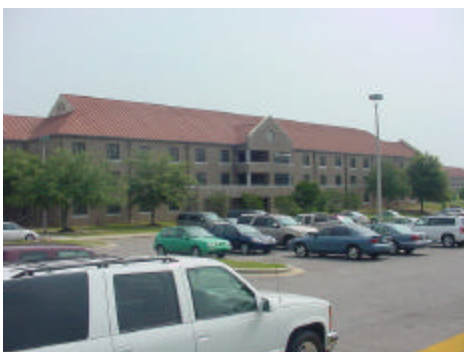
Building 24401 and 24405

Buildings 24401 and 24405, constructed in 1988, are identical 3-story buildings, each housing 92 shared bath/single rooms without kitchens and one standard stay room. Both of these buildings are in good condition but do not meet the Lodging size requirements. The cost to make improvements and bring up to Army Lodging standards will exceed the 50% replacement cost.

Our recommendation is to remove buildings 24401 and 24405 from the Lodging inventory, allowing the installation to determine an alternate use for these facilities. These facilities will be removed from the Fort Gordon Wellness Solution and Lodging Master Plan.

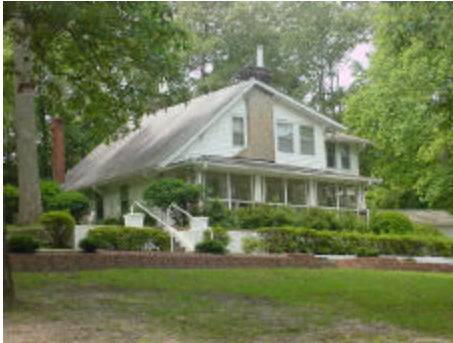
Building QTR #6

Building QTR #6, constructed in 1930, is a 2-story, wood frame house currently functioning as a single DVQ. This building is in good condition but does not meet the Lodging size requirements. The cost to make improvements and to bring up to Army Lodging standards will exceed the 50% replacement cost.

Our recommendation is to remove building QTR #6 from the Lodging inventory, allowing the installation to determine an alternate use for this facility. This facility will be removed from the Fort Gordon Wellness Solution and Lodging Master Plan.

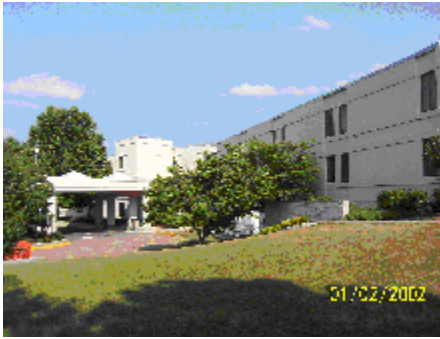
Building 0250

Building 250, also known as Griffith Hall, was constructed in 1967 and under went limited renovation in 2001. The 75,900 square foot facility contains 148 lodging rooms functioning as 132 standard stay rooms and 16 family suites.

This building is in good condition for both the Condition Assessment and Function Criteria. In this building the Condition Assessment costs include the wellness items and the Renovation Cost includes functional renovations but not Condition Assessment cost due to the limited nature of the renovation. Therefore in the Cost Analysis the sum of the Condition Assessment and Renovation cost is used for the ratio to the Replacement Cost

- Analysis: The roof covering is a membrane roof that is in poor condition.
- Recommendation: Replace the roofing.

- Analysis: The vinyl wall covering are in fair condition.
- Recommendation: Replace the vinyl wall coverings.

Because the Sum of the Condition Assessment & Renovation Cost to Replacement Cost Ratio is less than 50%, repair and continued use of Building 250 is recommended.
